New Hampshire Volunteer Lake Assessment Program

2003 Interim Report for Blaisdell Lake Sutton

NHDES
Water Division
Watershed Management Bureau
29 Hazen Drive
Concord, NH 03301

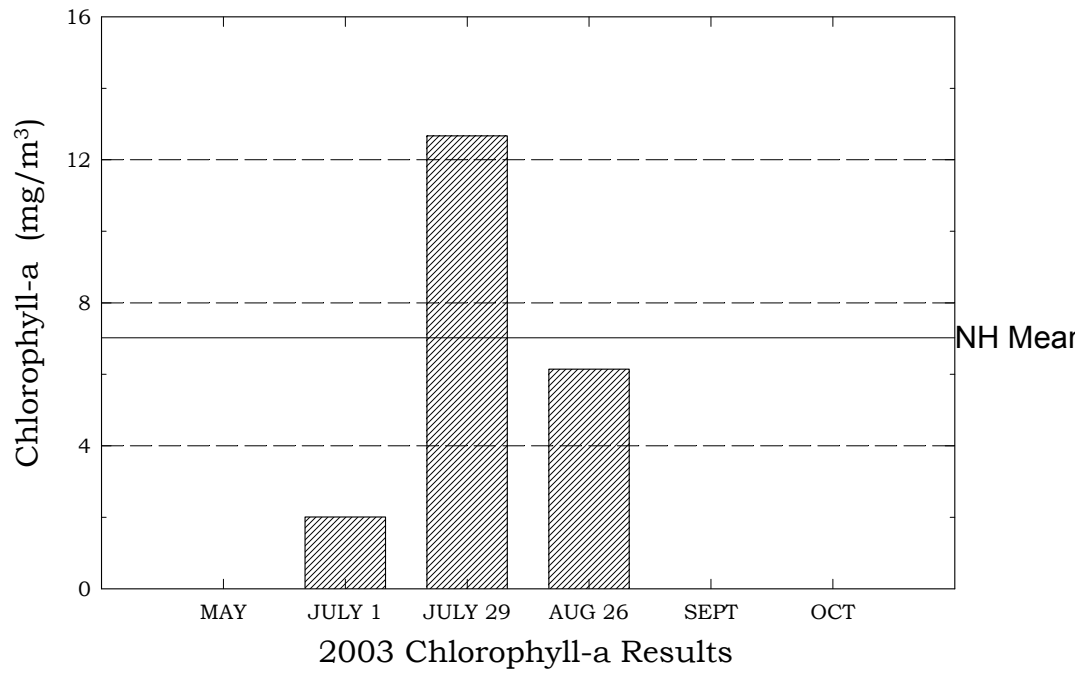
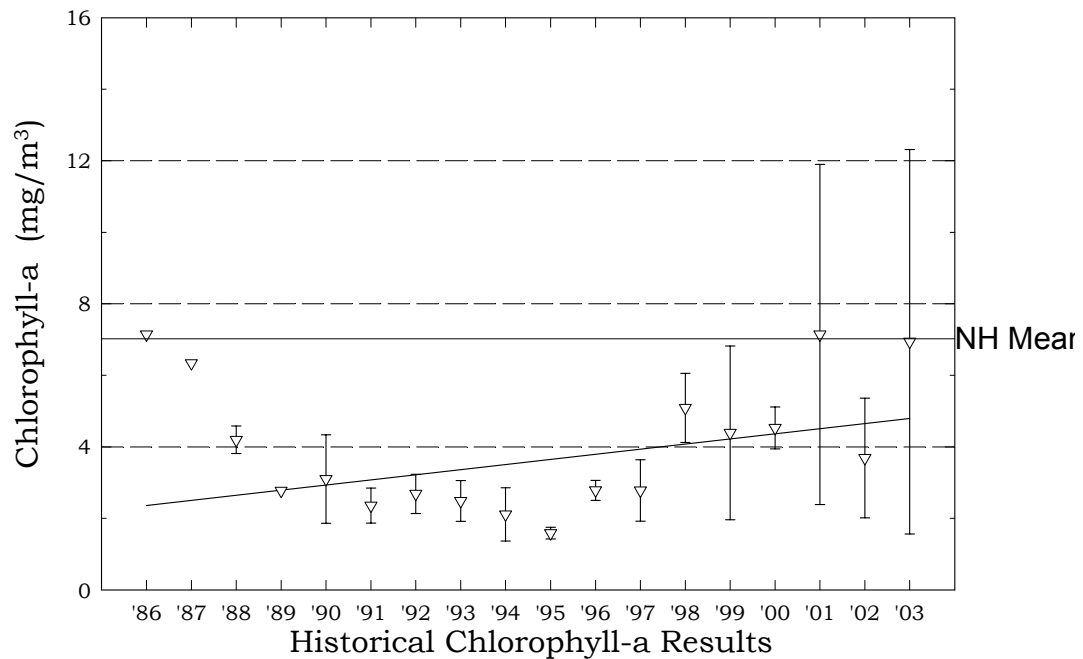
Figure 1. Monthly and Historical Chlorophyll-a Results

The current year data (the top graph) show that the chlorophyll-a concentration **increased greatly** from July 1 to July 29, and then **decreased** from July 29 to August 26. The chlorophyll-a concentration on July 1 and on August 26 was **less than** the state mean, while the chlorophyll-a concentration on July 29 was **greater than** the state median.

The historical data (the bottom graph) show that the 2003 chlorophyll-a mean is **approximately equal to** the state mean.

Overall, visual inspection of the historical data trend line (the bottom graph) shows **a variable, but overall slightly increasing** in-lake chlorophyll-a trend, meaning that the concentration has **fluctuated, but overall slightly worsened** since monitoring began. In the 2004 annual report, we will again be able to conduct a statistical analysis of the historic data to objectively determine if there has been a significant change in the annual mean chlorophyll-a concentration since monitoring began.

- **Figure 1 and Table 1:** The graphs in Figure 1 (Appendix A) show the historical and current year chlorophyll-a concentration in the water column. Table 1 (Appendix B) lists the maximum, minimum, and mean concentration for each sampling season that the lake has been monitored through the program.

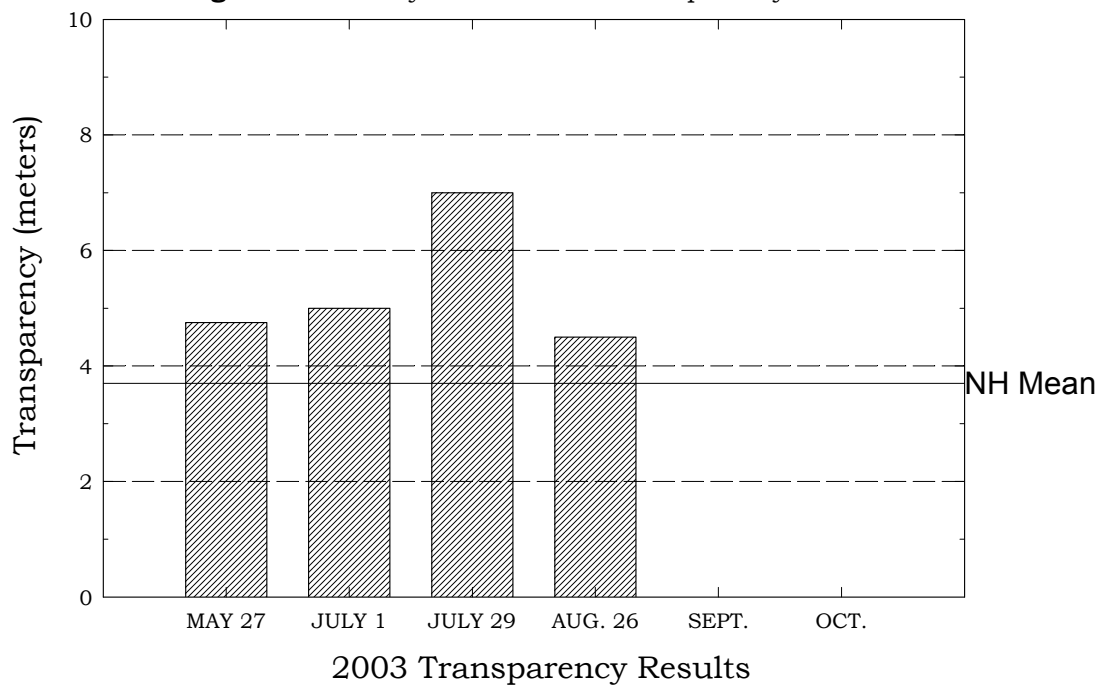
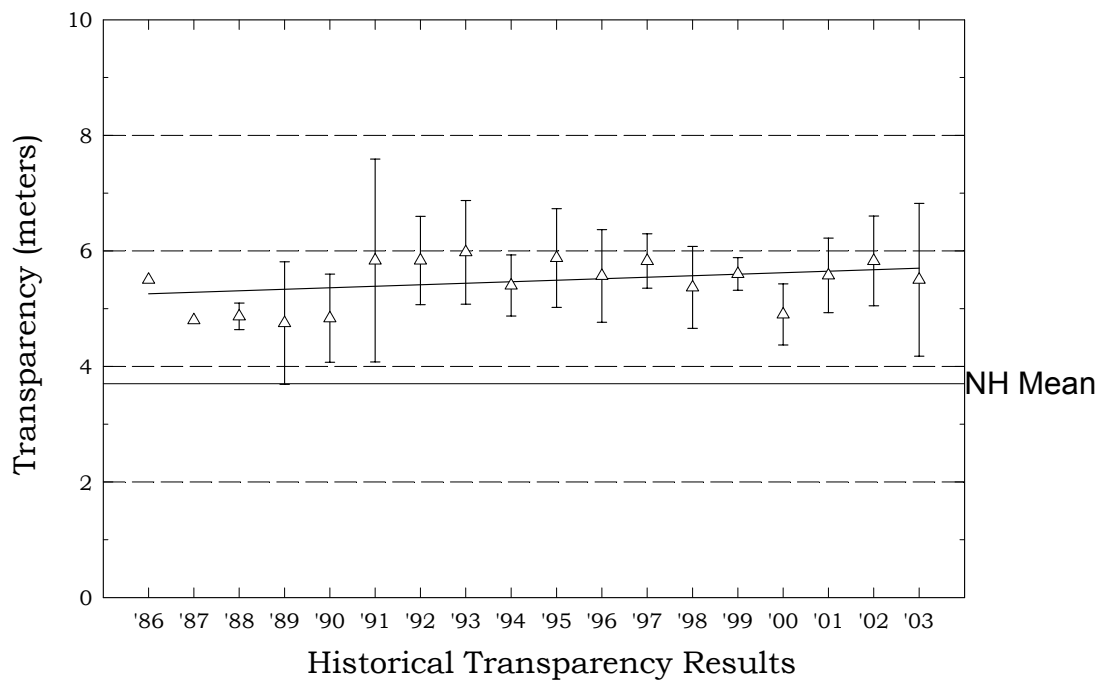
Figure 2. Monthly and Historical Transparency Results

The current year data (the top graph) show that the in-lake transparency **remained relatively stable** from May 27 to July 1, **increased** from July 1 to July 29, and then **decreased** from July 29 to August 26. The transparency on each sampling event was **greater than** the state mean.

Overall, visual inspection of the historical data trend line (the bottom graph) shows **a stable** trend for in-lake transparency, meaning that the transparency has **remained approximately the same** since monitoring began. After 10 consecutive years of sample collection, we will be able to conduct a statistical analysis of the historic data to objectively determine if there has been a significant change in the annual mean transparency since monitoring began.

- **Figure 2 and Table 3:** The graphs in Figure 2 (Appendix A) show historical and current year data for lake transparency. Table 3 (Appendix B) lists the maximum, minimum and mean transparency data for each sampling season that the lake has been monitored through the program.

Typically, high intensity rainfall causes erosion of sediments into lakes and streams, thus decreasing clarity. Efforts should continually be made to stabilize stream banks, lake shorelines, disturbed soils within the watershed, and especially dirt roads located immediately adjacent to the edge of tributaries and the lake. Guides to Best Management Practices designed to reduce, and possibly even eliminate, nonpoint source pollutants, such as sediment loading, are available from DES upon request.

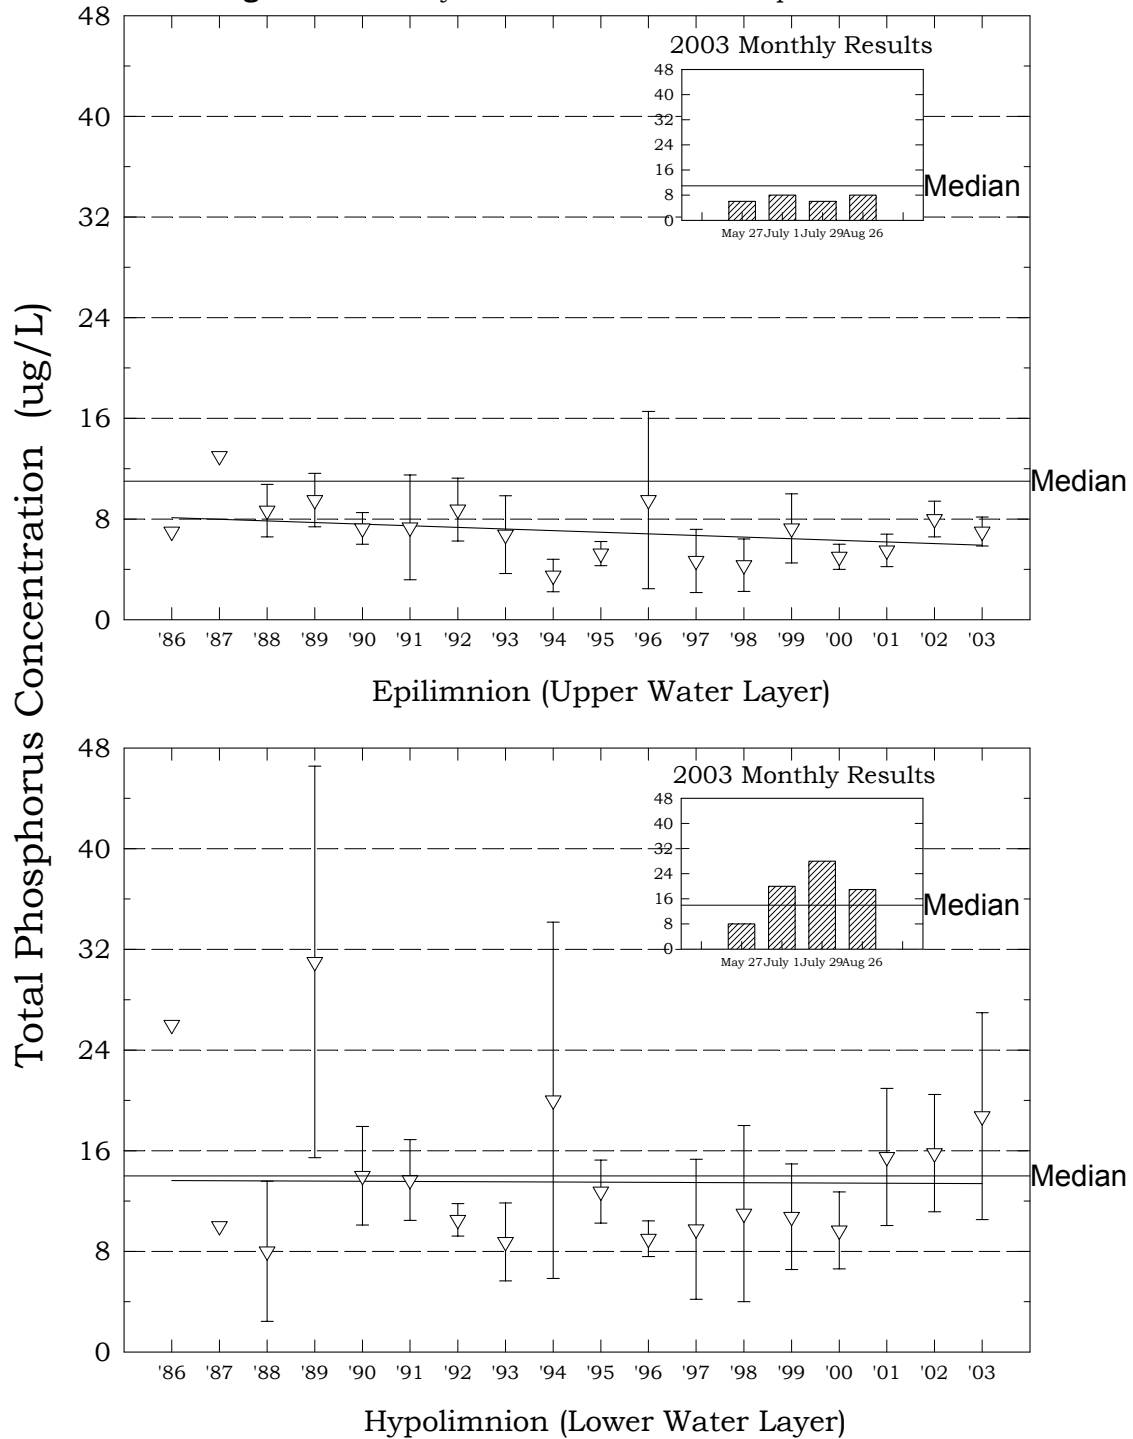
Figure 3. Monthly and Historical Total Phosphorus Data.

The current year data for the epilimnion (the top inset graph) show that the phosphorus concentration **remained relatively stable** (ranging from 6 to 8 ug/L) during all sampling events this season. The phosphorus concentration on each sampling event was **less than** the state median.

The current year data for the hypolimnion (the bottom inset graph) show that the phosphorus concentration **increased** from May 27 to July 29, and then **decreased** from July 29 to August 26. The phosphorus concentration on May 27 was **less** than the state median, while the phosphorus concentration on July 1, July 29, and August 26 was **greater than** the state median.

The historical data show that the 2003 mean hypolimnetic phosphorus concentration is **greater than** the state median.

Overall, visual inspection of the historical data trend line for the epilimnion show a **slightly declining** phosphorus trend, which means that the concentration has **slightly improved** in the epilimnion since monitoring began.

Overall, visual inspection of the historical data trend line for the hypolimnion shows **variable, but overall stable** phosphorus trend, which means that the concentration has **fluctuated, but has not continually increased or decreased** in the hypolimnion since monitoring began.

- **Figure 3 and Table 8:** The graphs in Figure 3 (Appendix A) show the amounts of phosphorus in the epilimnion (the upper layer) and the hypolimnion (the lower layer); the inset graphs show current year data. Table 8 (Appendix B) lists the annual maximum, minimum, and median concentration for each deep spot layer and each tributary since the lake has joined the program.

One of the most important approaches to reducing phosphorus loading to a waterbody is to continually educate watershed residents about its sources and how excessive amounts can adversely impact the ecology and value of lakes and ponds. Phosphorus sources within a lake or pond's watershed typically include septic systems, animal
